Monitoring Data Record

Project Title: U-2524AB (Site 3) COE Action ID: 200321137  
 Stream Name: UT #3 Reddicks Creek DWQ Number: 030909  
 City, County and other Location Information: Greensboro Western Loop, Guilford Co.  
Sta. 34+00 to Sta. 37+10 -L-  
 Date Construction Completed: Water was turned into the stream on June 2005 and planted  
January 2007. Monitoring Year: ( 5 ) of 5  
 Ecoregion: \_\_\_\_\_ 8 digit HUC unit 03030002  
 USGS Quad Name and Coordinates: \_\_\_\_\_

# UT #3 Reddicks Creek

## Site 3

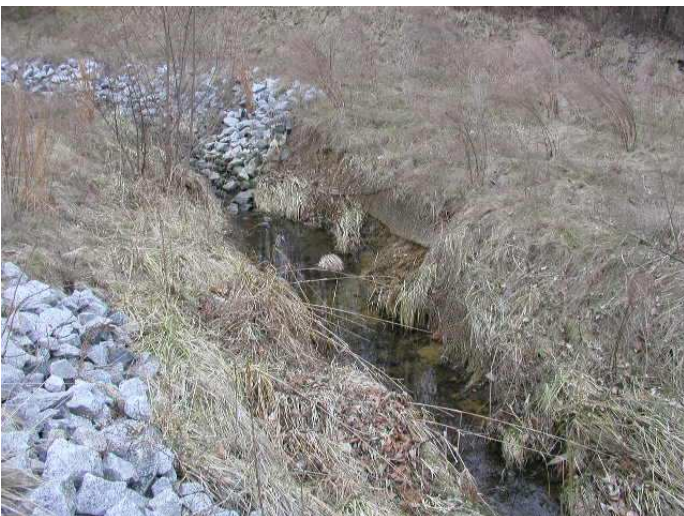
Photo Point #6 (Upstream)

The UT #3 Reddicks Creek stream relocation is stable for the Year 5 Winter evaluation, except for, some minor bank scouring noted on the left bank at Photo Point #6 (upstream) which had little or no change since the last evaluation. NCDOT will continue to monitor this stream relocation.

1/24/11	PP#6 (Upstream) Sta. 36+80	Station Number	Station Number	Station Number	Station Number
Structure Type					
Is water piping through or around structure?					
Head cut or down cut present?					
Bank or scour erosion present?	Minor bank scouring on left bank
